**HYDRAULIC MODEL  
INVESTIGATION**

AD-A134 641  
**Placer Creek High-Velocity Channel  
and Debris Basin at Wallace, Idaho**

**SPONSORED BY  
U. S. ARMY CORPS OF ENGINEERS  
SEATTLE DISTRICT**

**CONDUCTED BY  
DIVISION HYDRAULIC LABORATORY  
U. S. ARMY CORPS OF ENGINEERS  
NORTH PACIFIC DIVISION  
BONNEVILLE, OREGON**

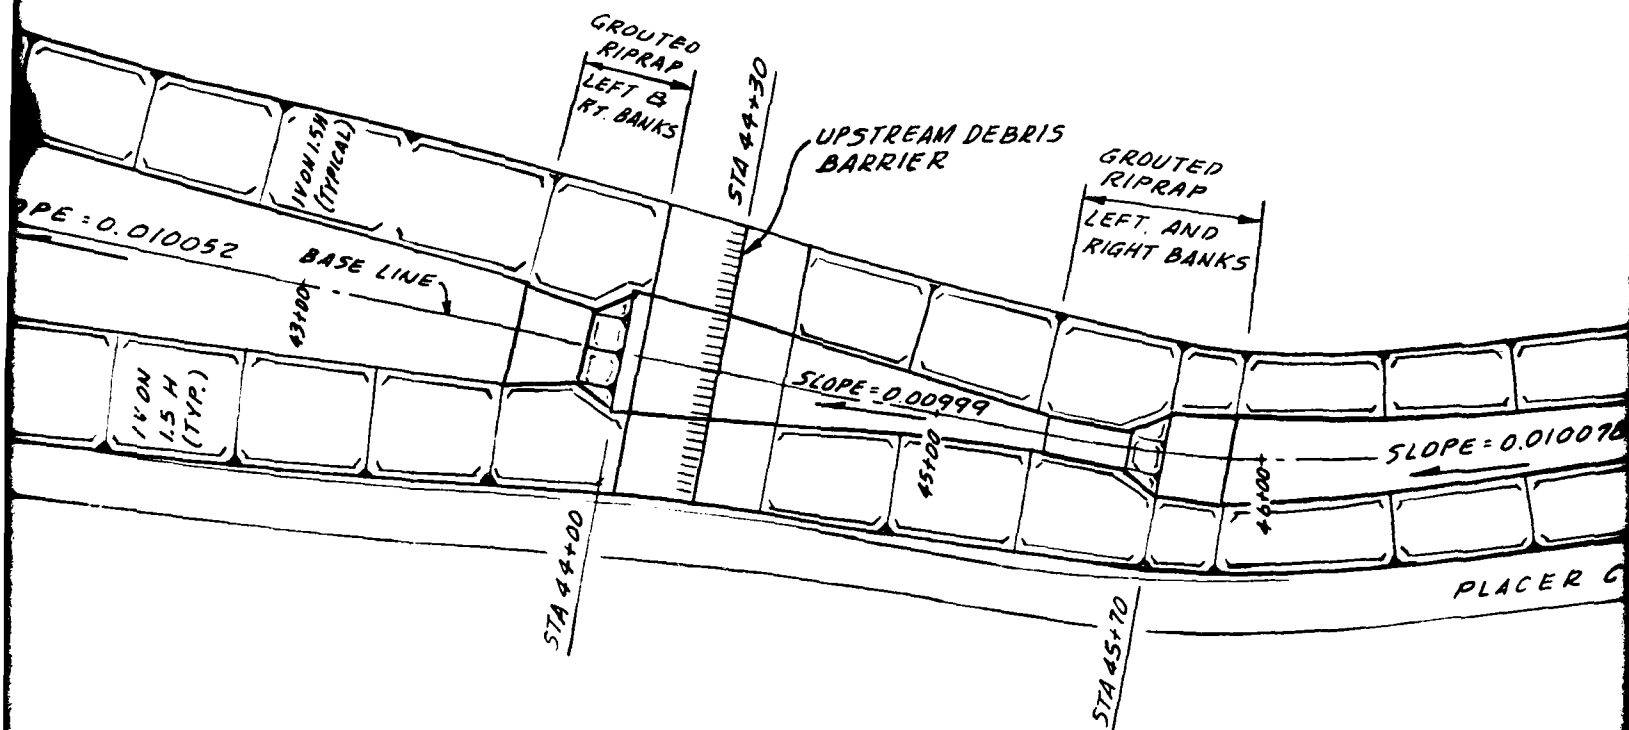
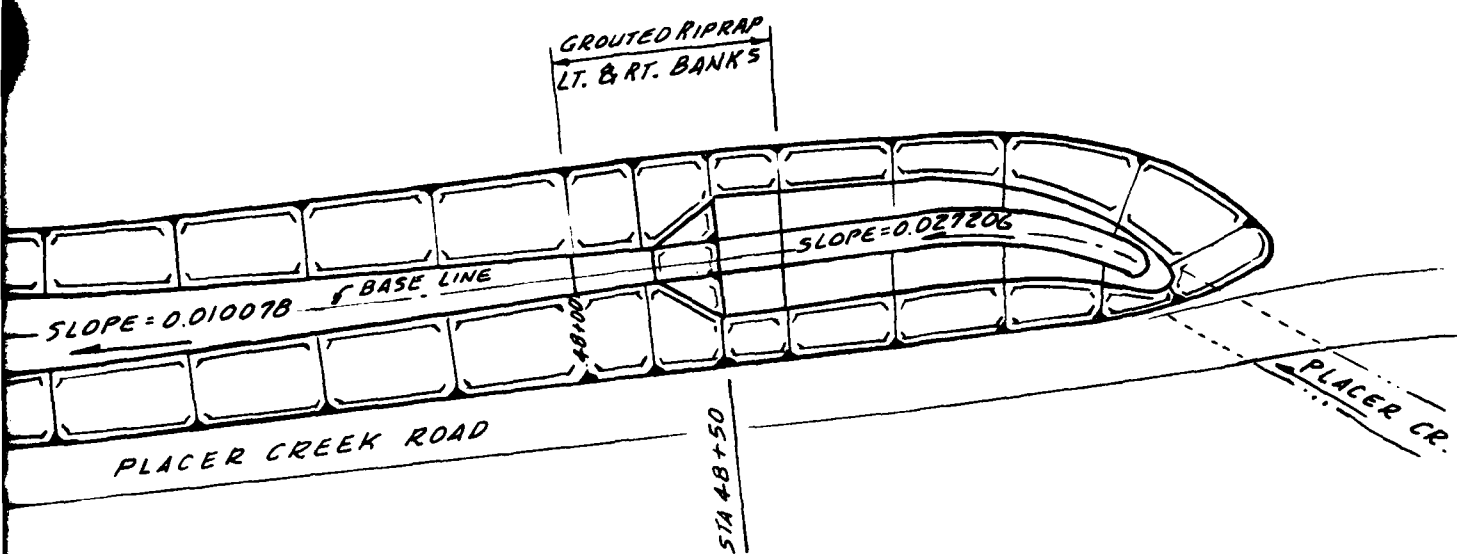
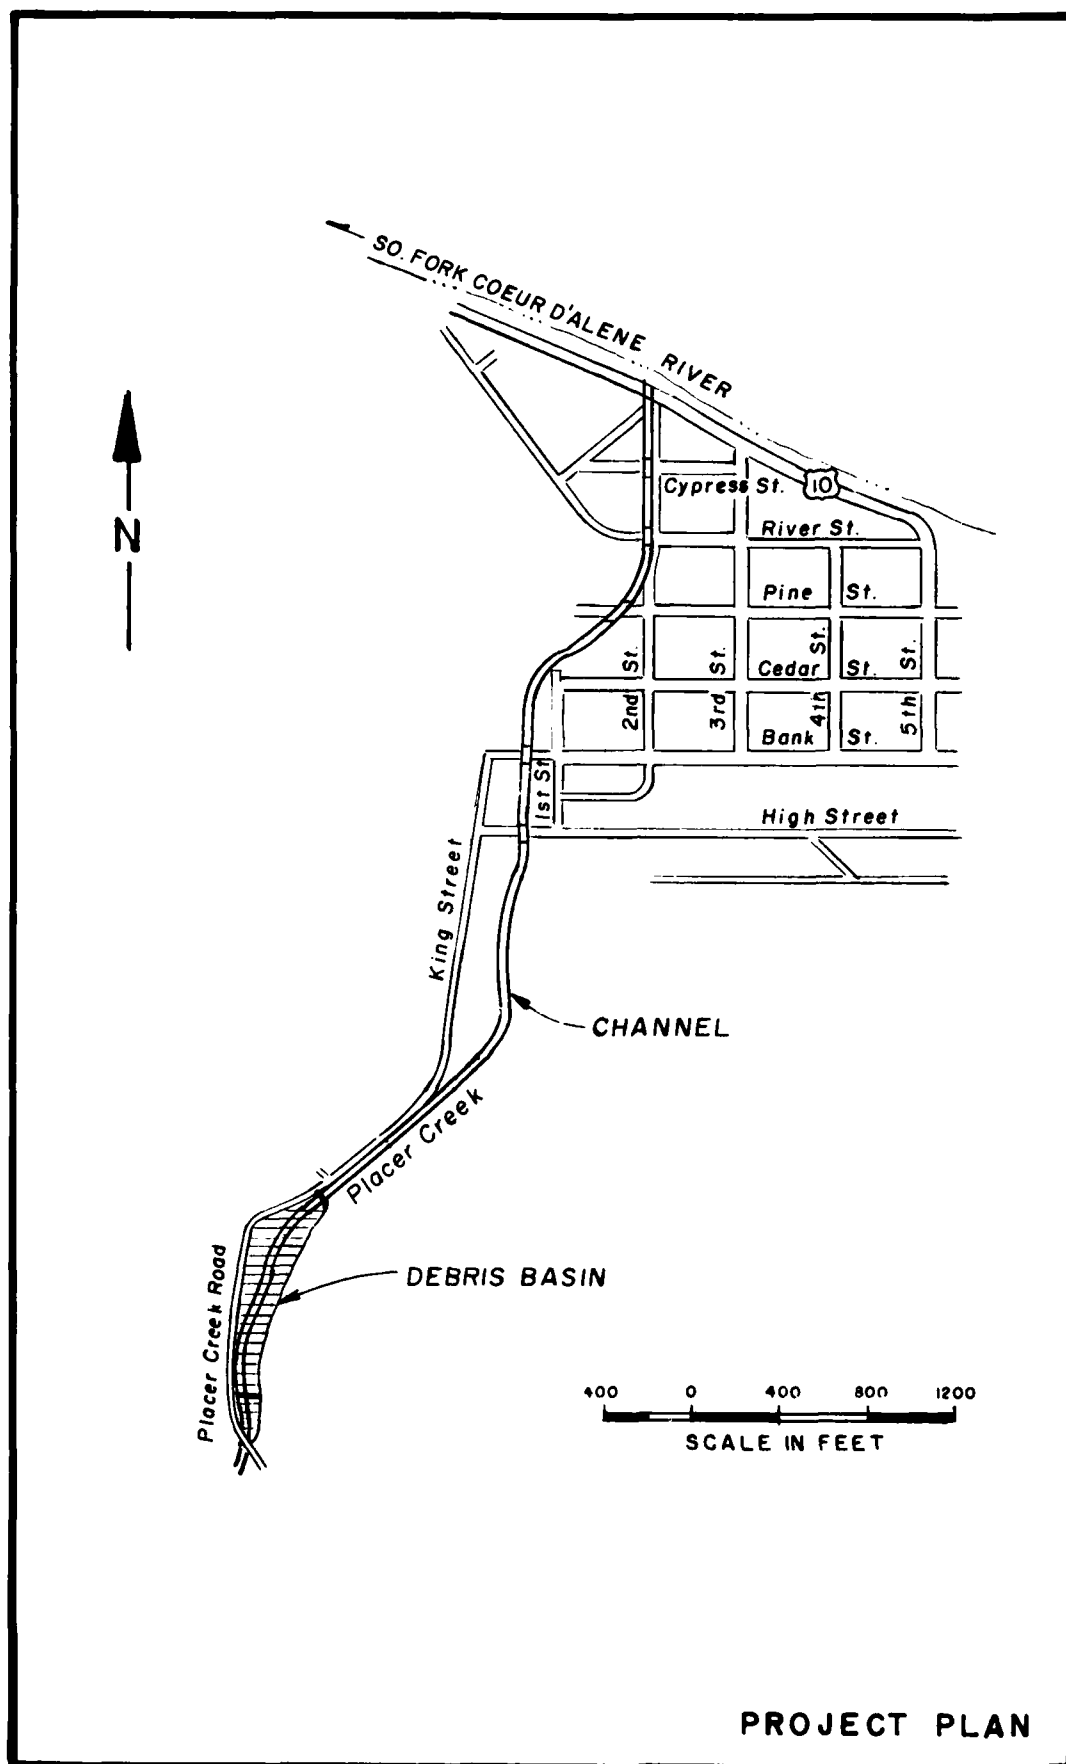
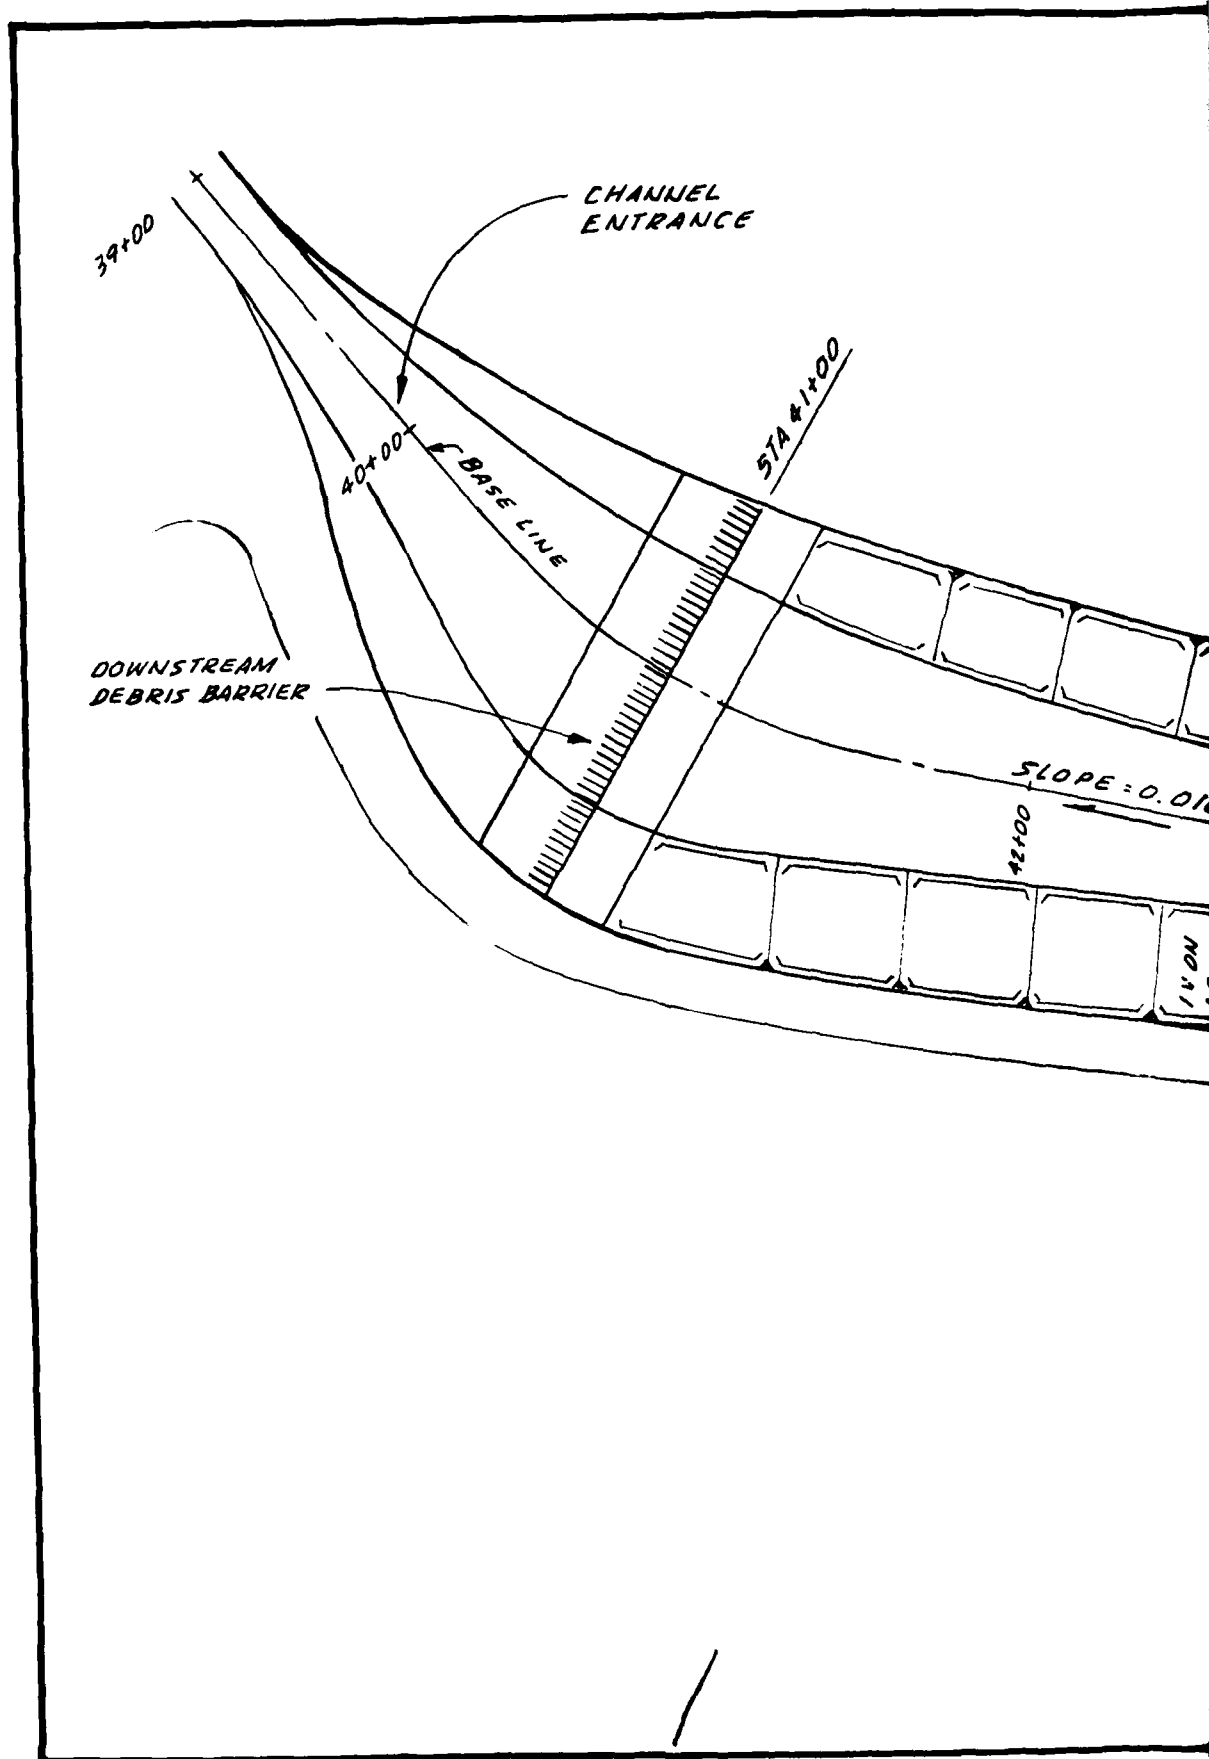
PLAN  
DEBRIS BASIN  
ORIGINAL DESIGN

SCALE 1" = 40'

40. The original design debris basin proved to be ineffective and required redesign. The final design basin effectively dissipated the energy of the incoming flow and reduced velocities sufficiently to cause deposition of debris load. Tests were conducted by supplying debris load to both the 200-year winter rainflood hydrograph and the 200-year thunderstorm (design condition) hydrograph and demonstrated the effectiveness of the basin in collecting and trapping the debris and preventing debris from entering the channel. In February 1982, an approximate 10-year flood occurred and deposited about 3,000 cu yd of material in the basin which had been essentially completed. The basin prevented any debris from passing into the channel downstream, and material deposition in the prototype was very similar to that predicted by the model. Photographs 68 and 69 show the effectiveness of the debris basin in preventing debris from entering the concrete-lined flood control channel.

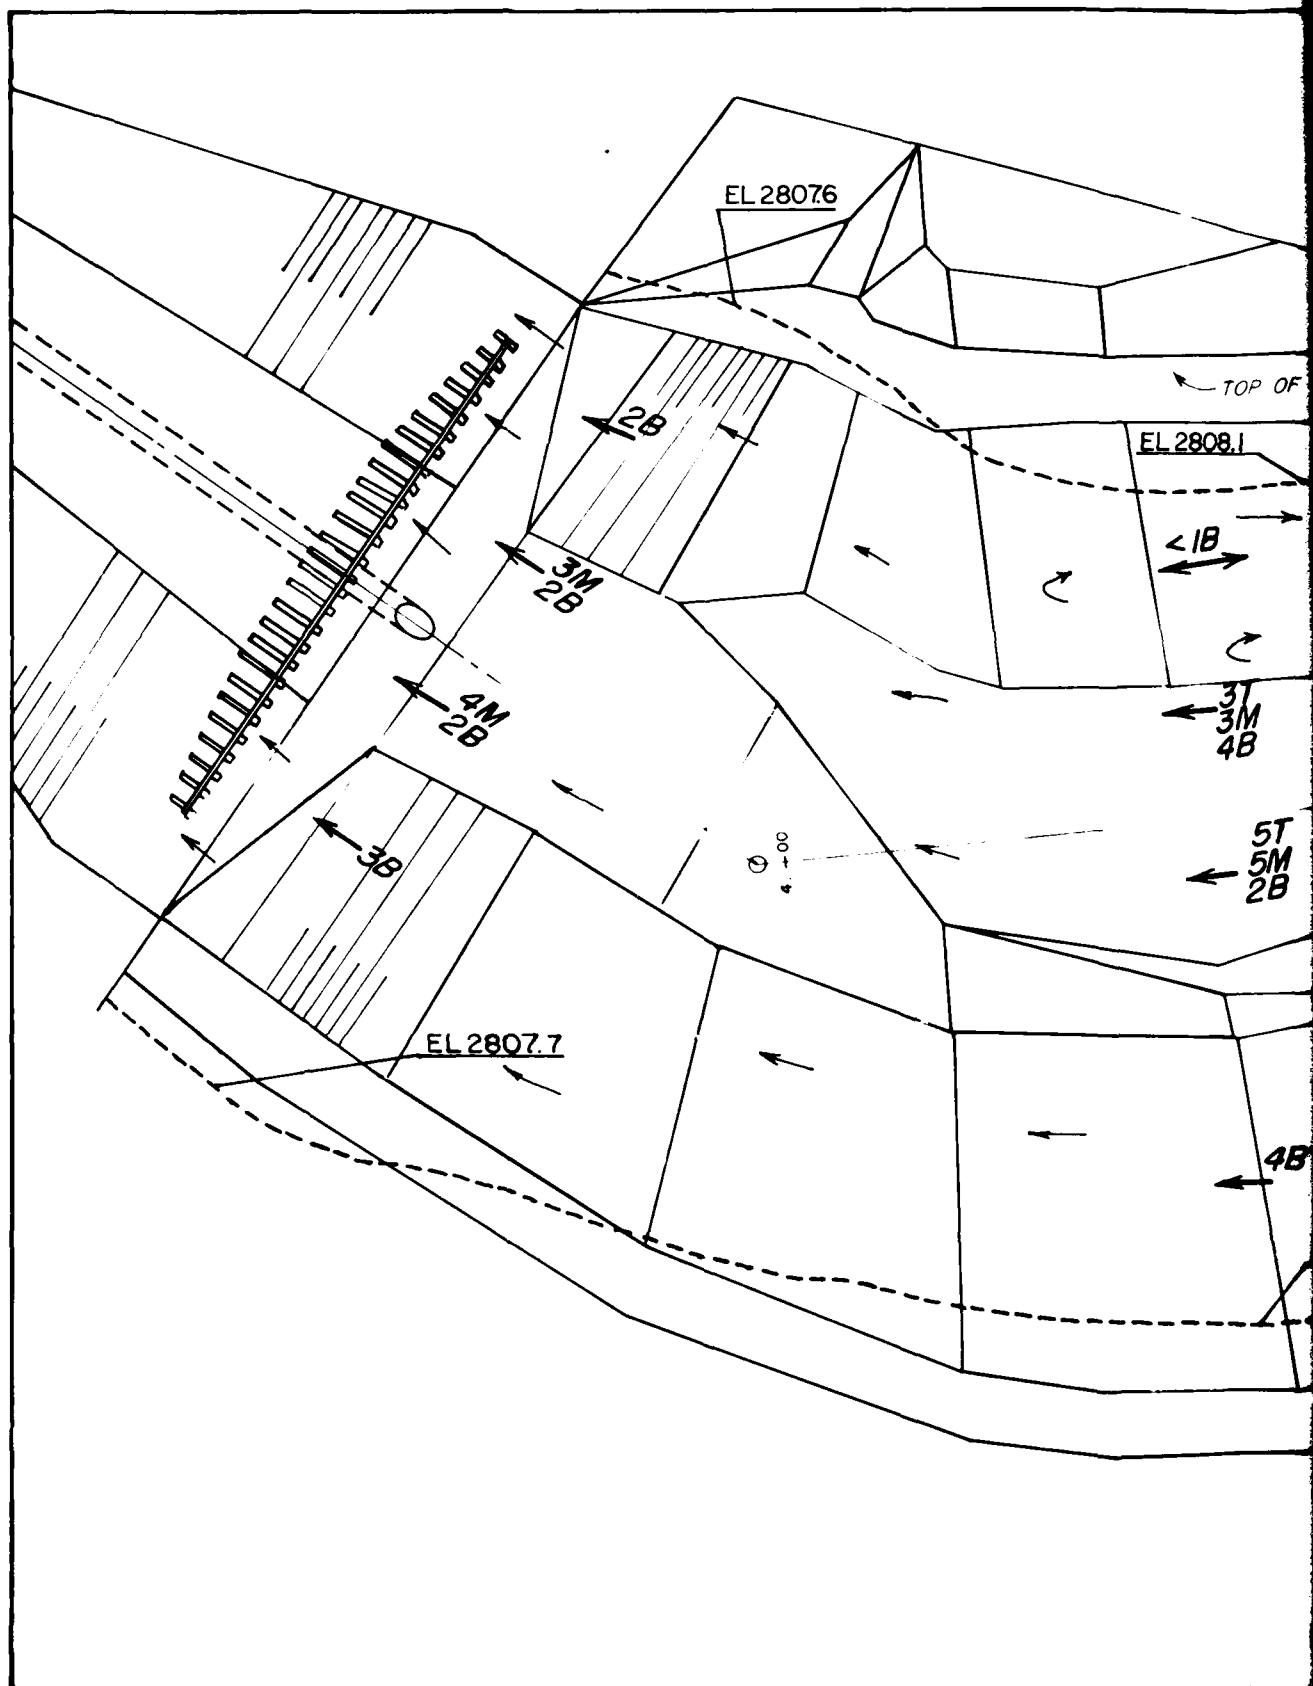
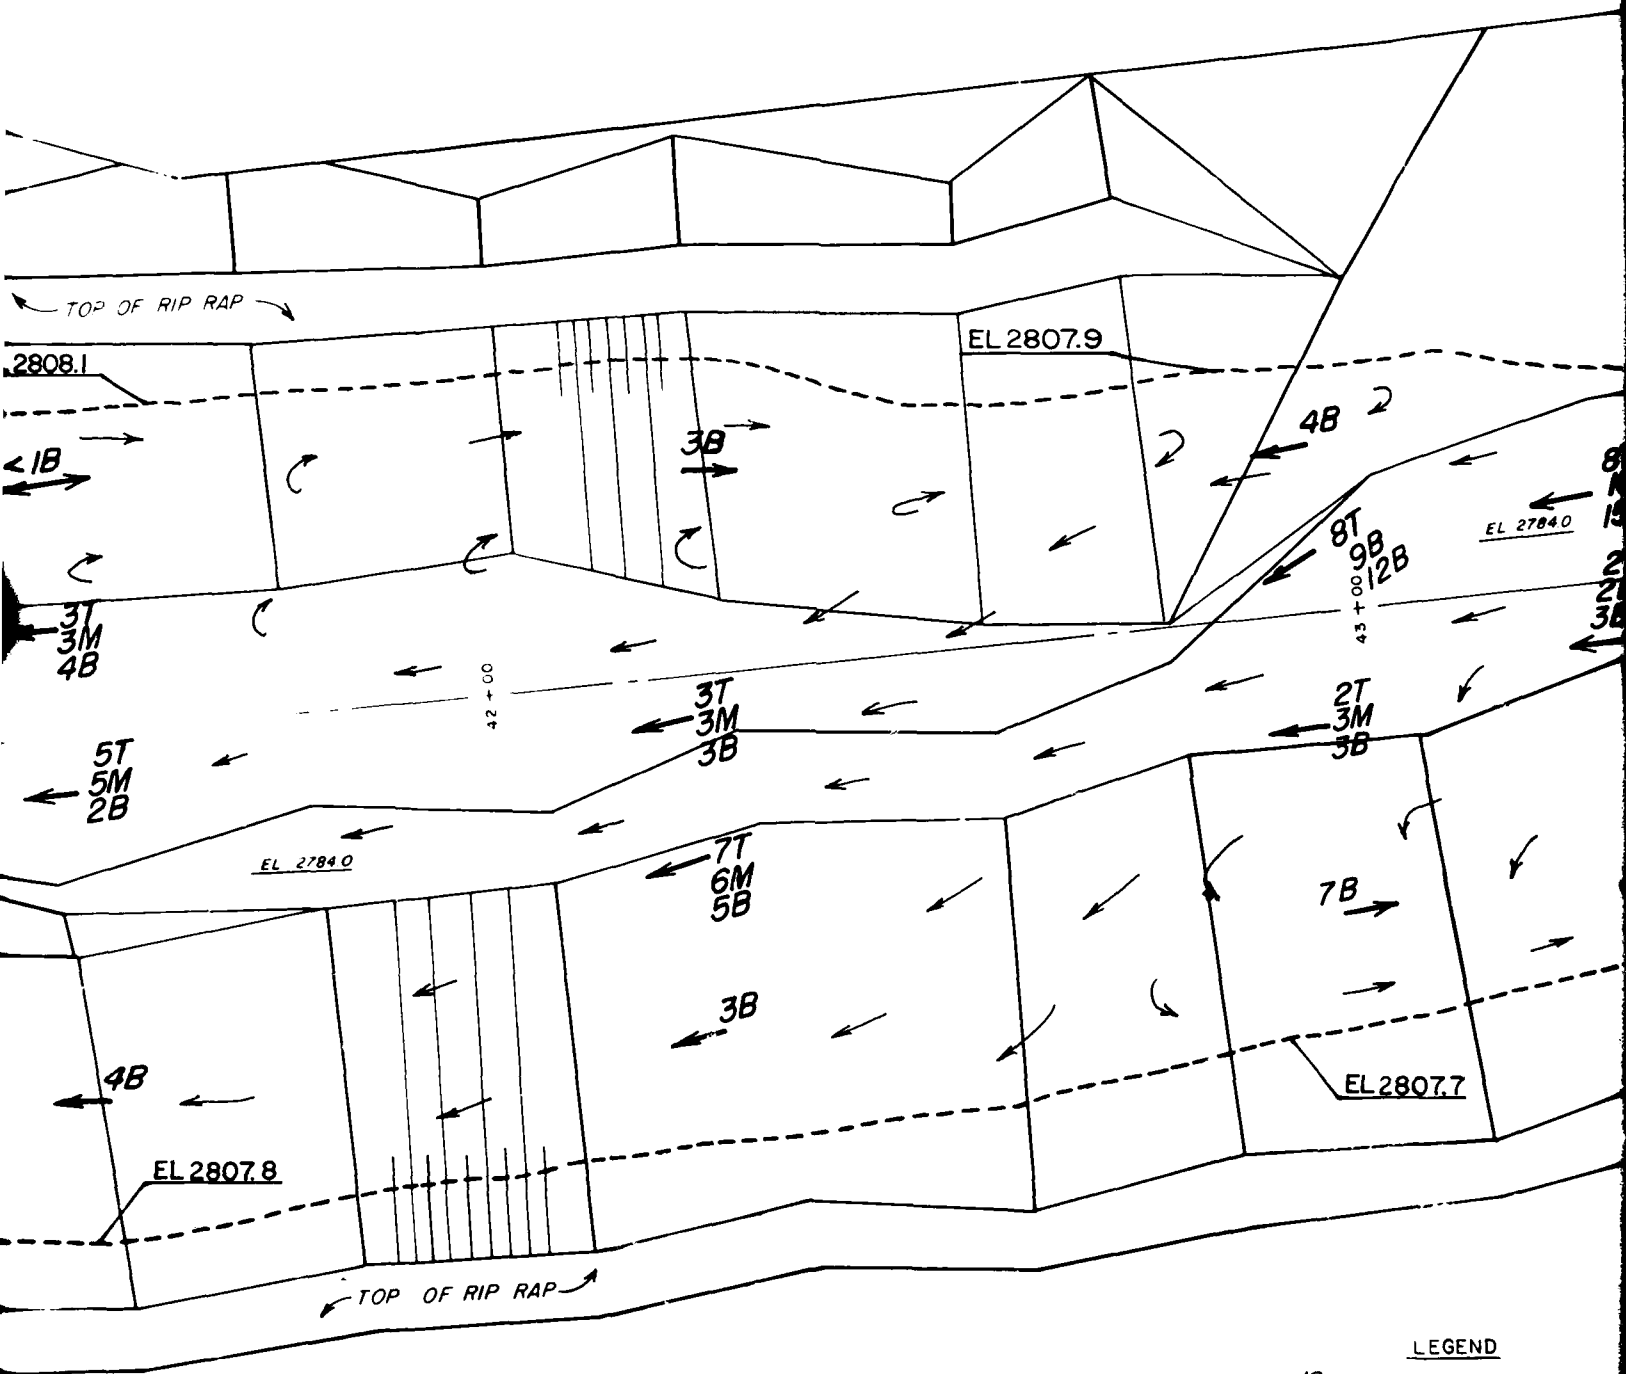
PLAN  
 DEBRIS BASIN  
 FINAL DESIGN

**LEGEND**

10 VELOCITIES MEASURED IN  
 T 2-FT DEPTH  
 M MID-DEPTH  
 B 2 FT ABOVE BOTTOM  
 2807.8 WATER-SURFACE ELEVAT

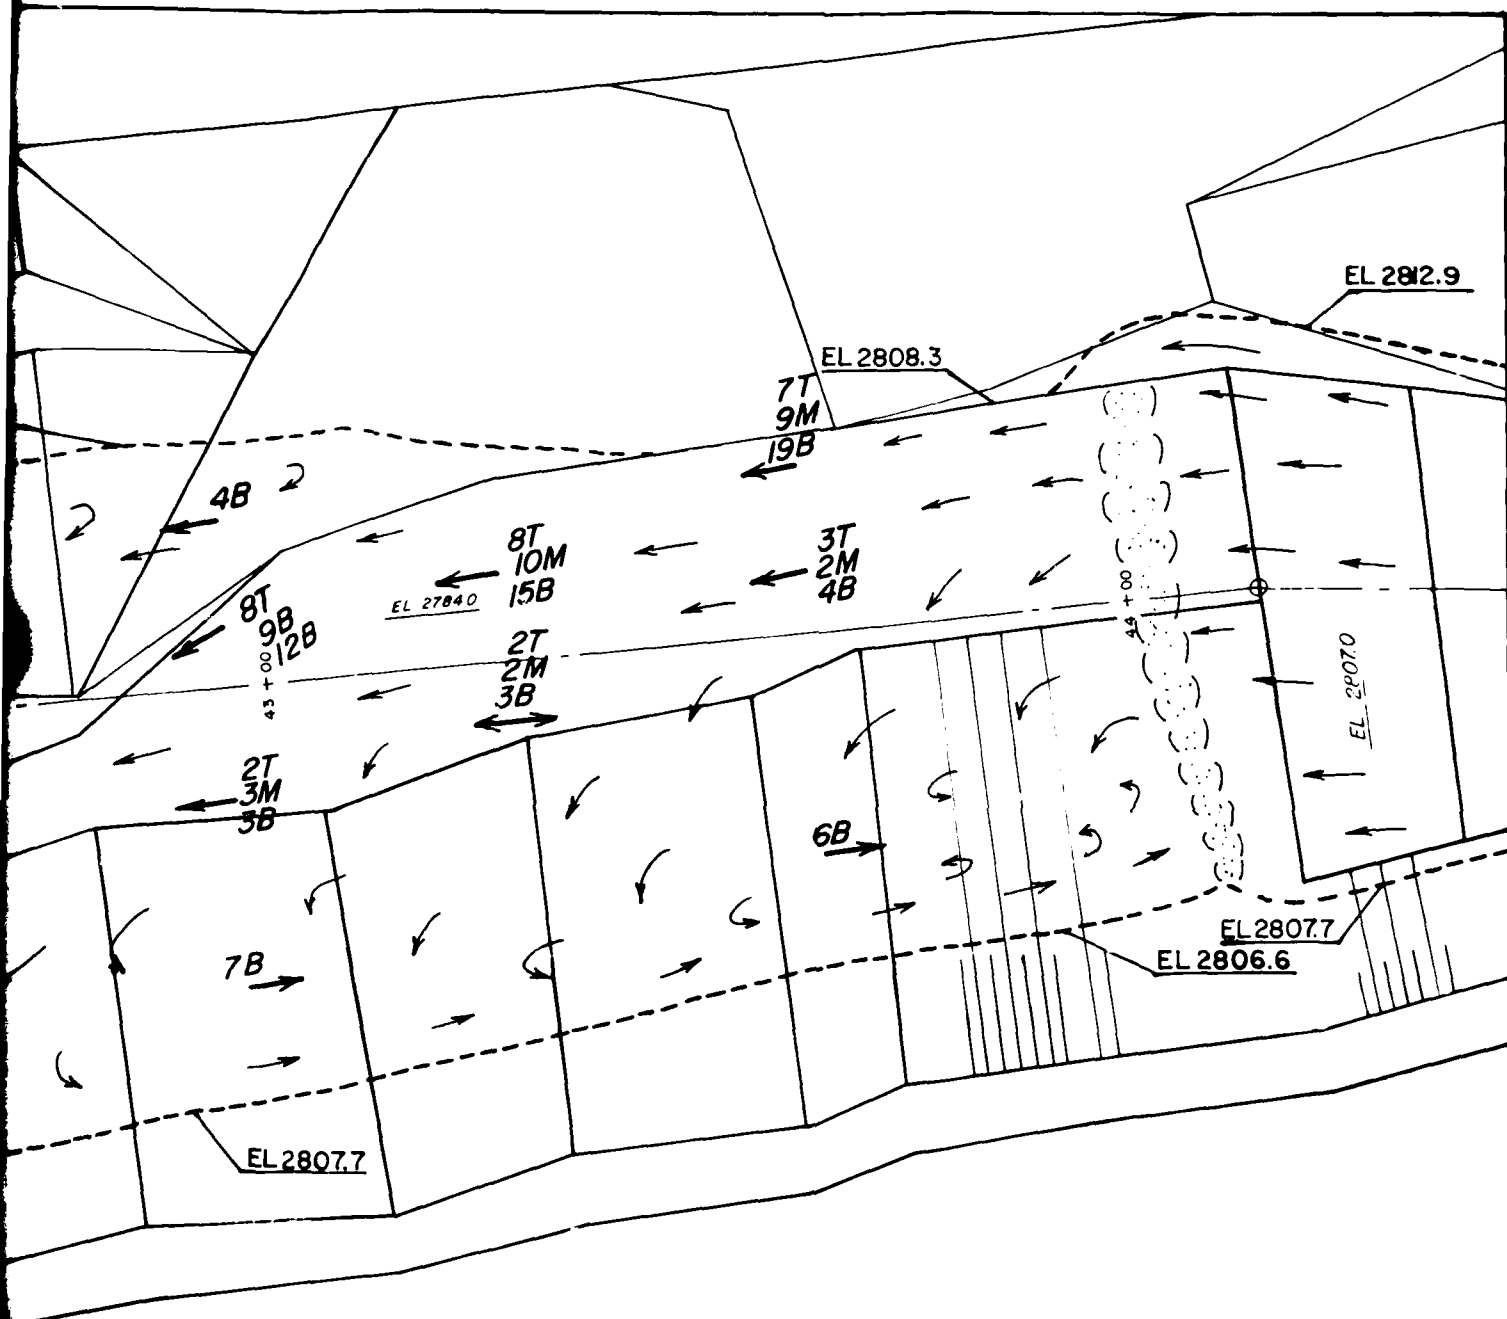
FINAL DESIGN DEBRIS BASIN

# LEGEND

10 VELOCITIES MEASURED IN FPS  
 T 2-FT DEPTH  
 M MID-DEPTH  
 B 2 FT ABOVE BOTTOM  
 2807.8 WATER-SURFACE ELEVATIONS

FLOW CONDITIONS

PLACER CREEK DISCHARGE 4600 CFS

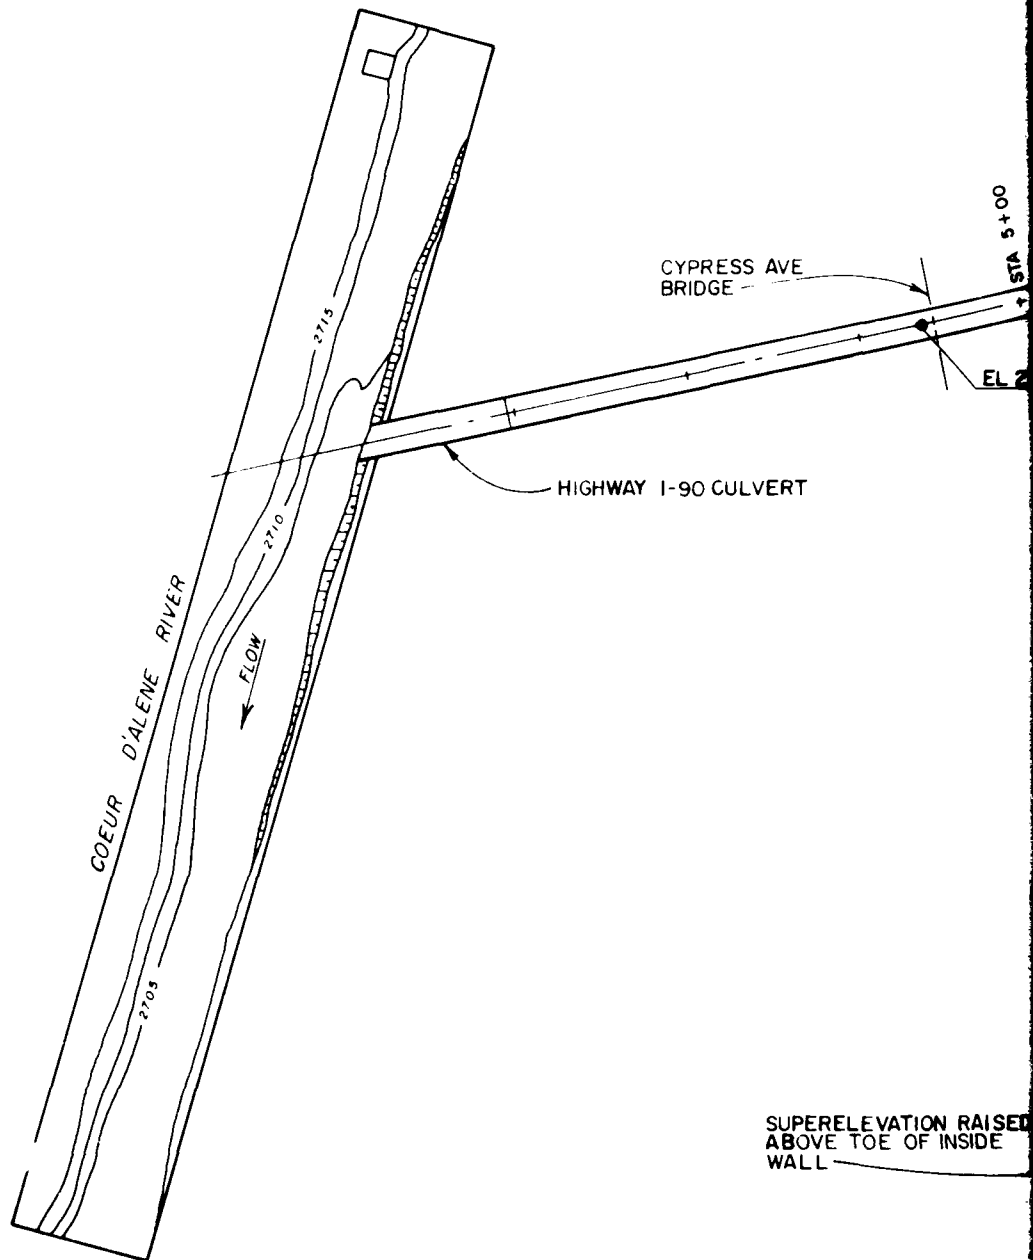
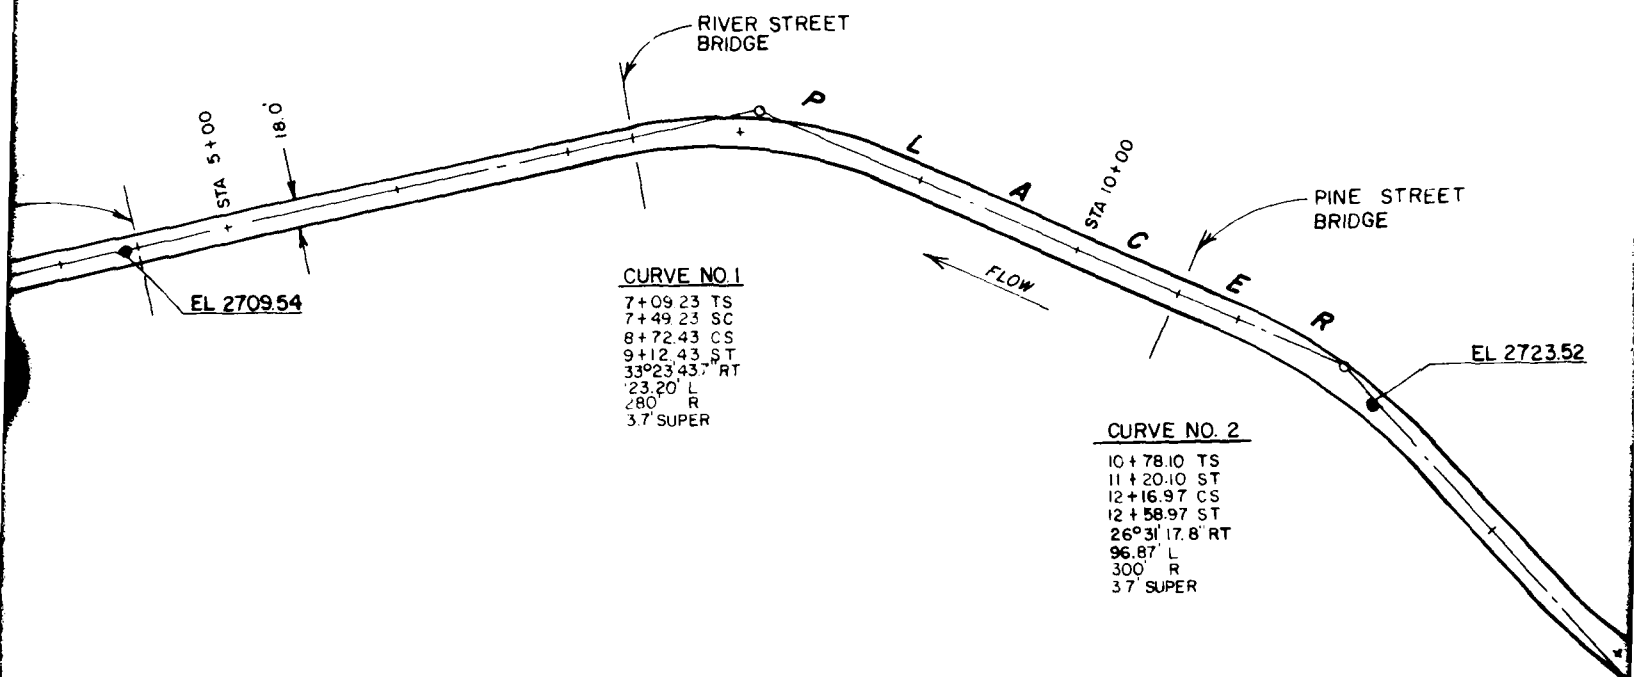
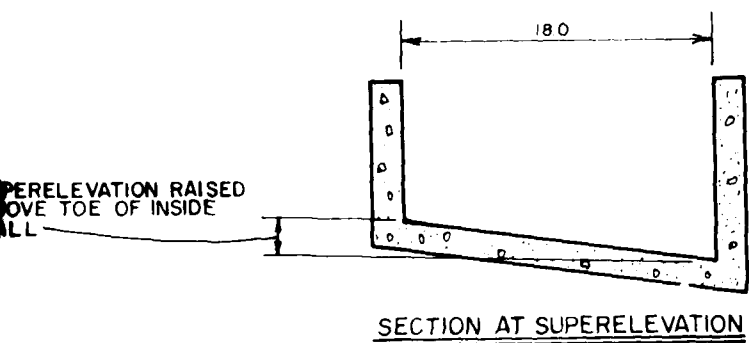
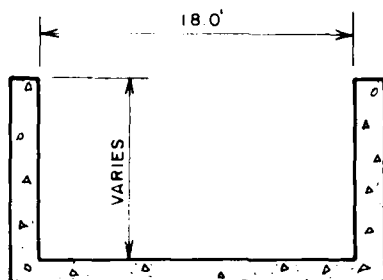
PLATE 5

TYPICAL SECTION

CURVE NO. 3

13+17.43 TS  
13+58.43 SC  
16+02.11 CS  
16+43.11 ST  
5°22'10.3" LT  
243.68' L  
300' R  
36' SUPER

CURVE NO. 5

8+07.25 PC  
18+26.43 PT  
3°39'46.7" RT  
1918' L  
300' R

22. Model layout and details of the original channel design are shown on plates 5 and 6. Photographs 39 to 44 show typical channel geometry. Tests were conducted with discharges of 1,000, 2,400, 3,300, and 4,600 cfs (design flow). Hydraulic conditions throughout the channel were acceptable for all discharges with the exception that downstream from curves 4 and 5 unacceptable standing waves were created which continued downstream (photograph 45). In the original design, curves 4 and 5 essentially formed a reverse curve which did not incorporate spirals or superelevation due to shortness of the curves and their close proximity.

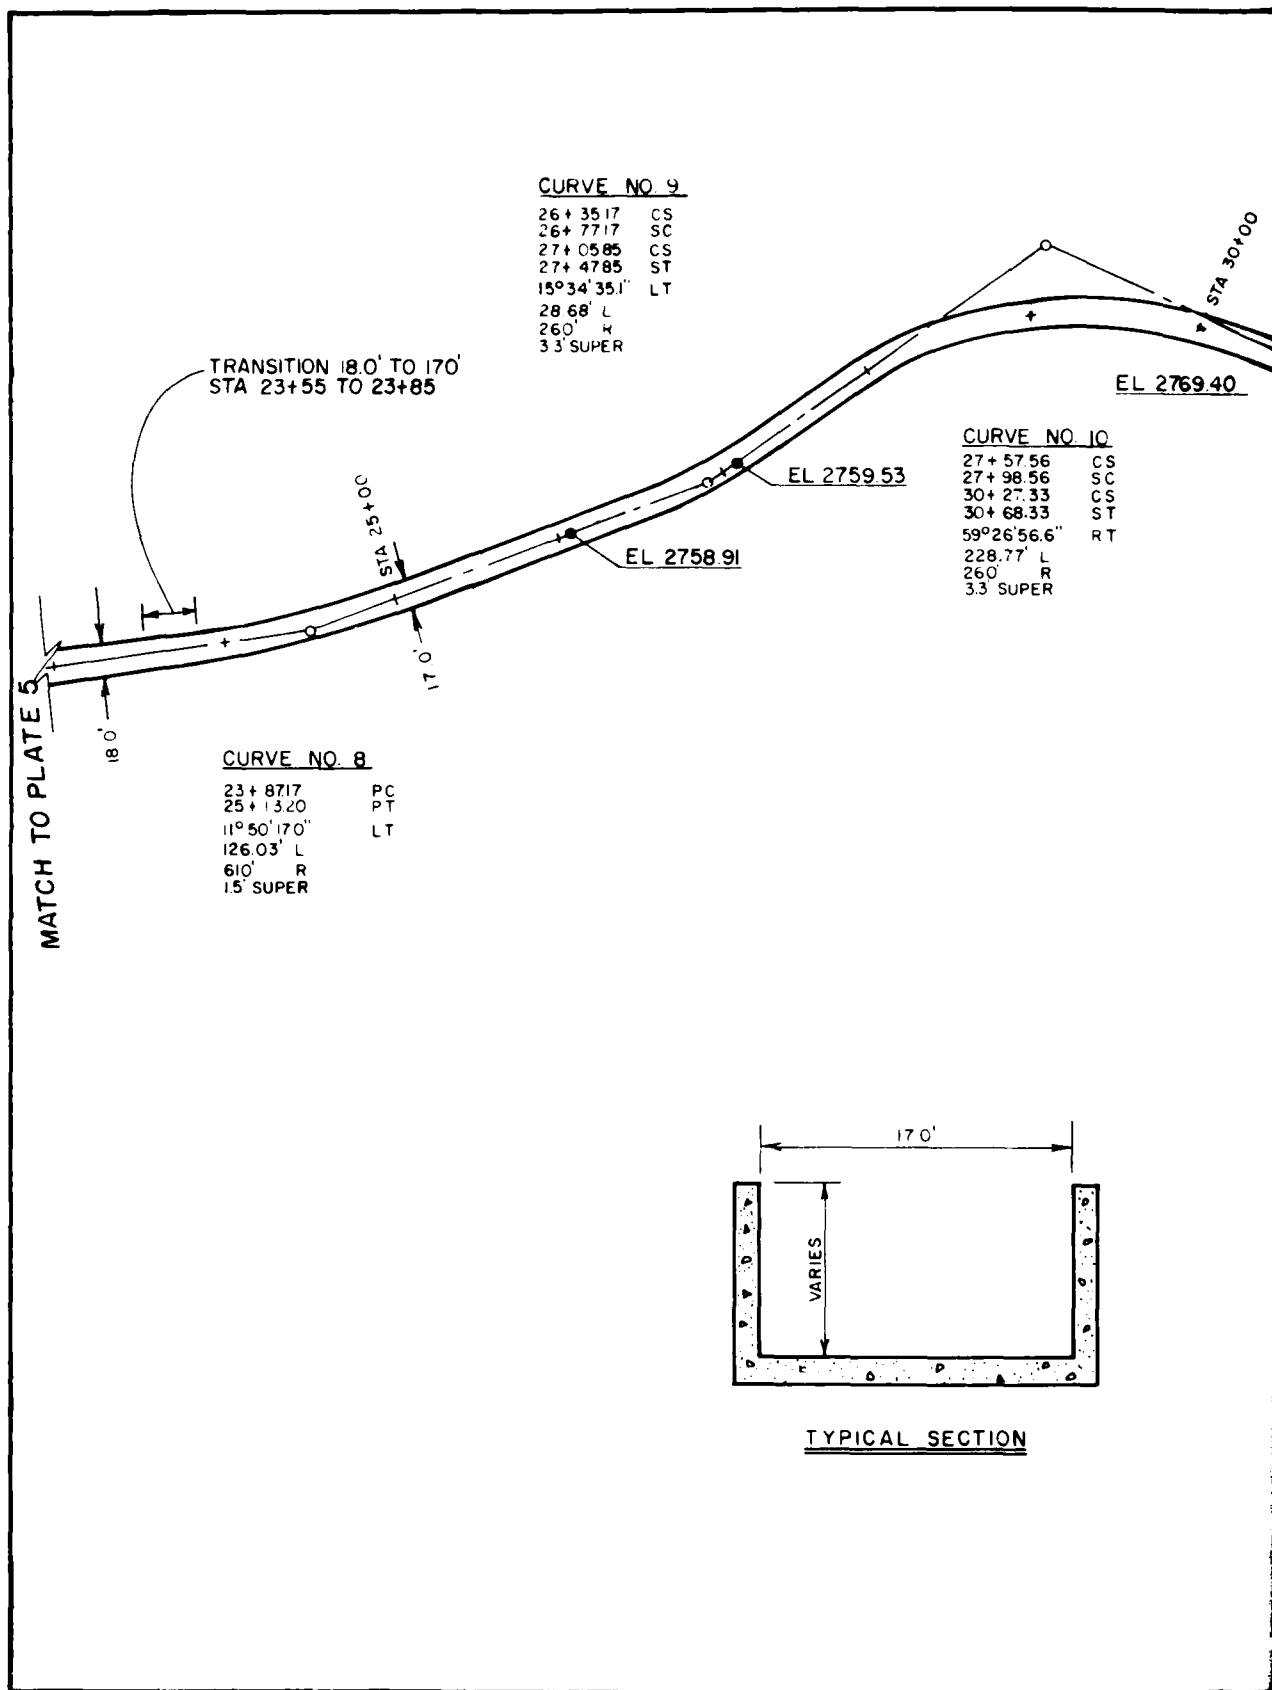
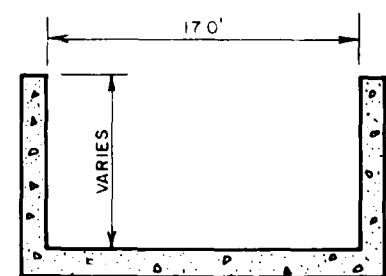
PLATE 6

CURVE NO. 9

26+35.17 CS  
 26+77.17 SC  
 27+05.85 CS  
 27+47.85 ST  
 15°34'35.1" LT  
 28.68' L  
 260' R  
 3.3 SUPER

CURVE NO. 8

23+87.17 PC  
 25+13.20 PT  
 11°50'17.0" LT  
 126.03' L  
 610' R  
 1.5 SUPER

TYPICAL SECTION

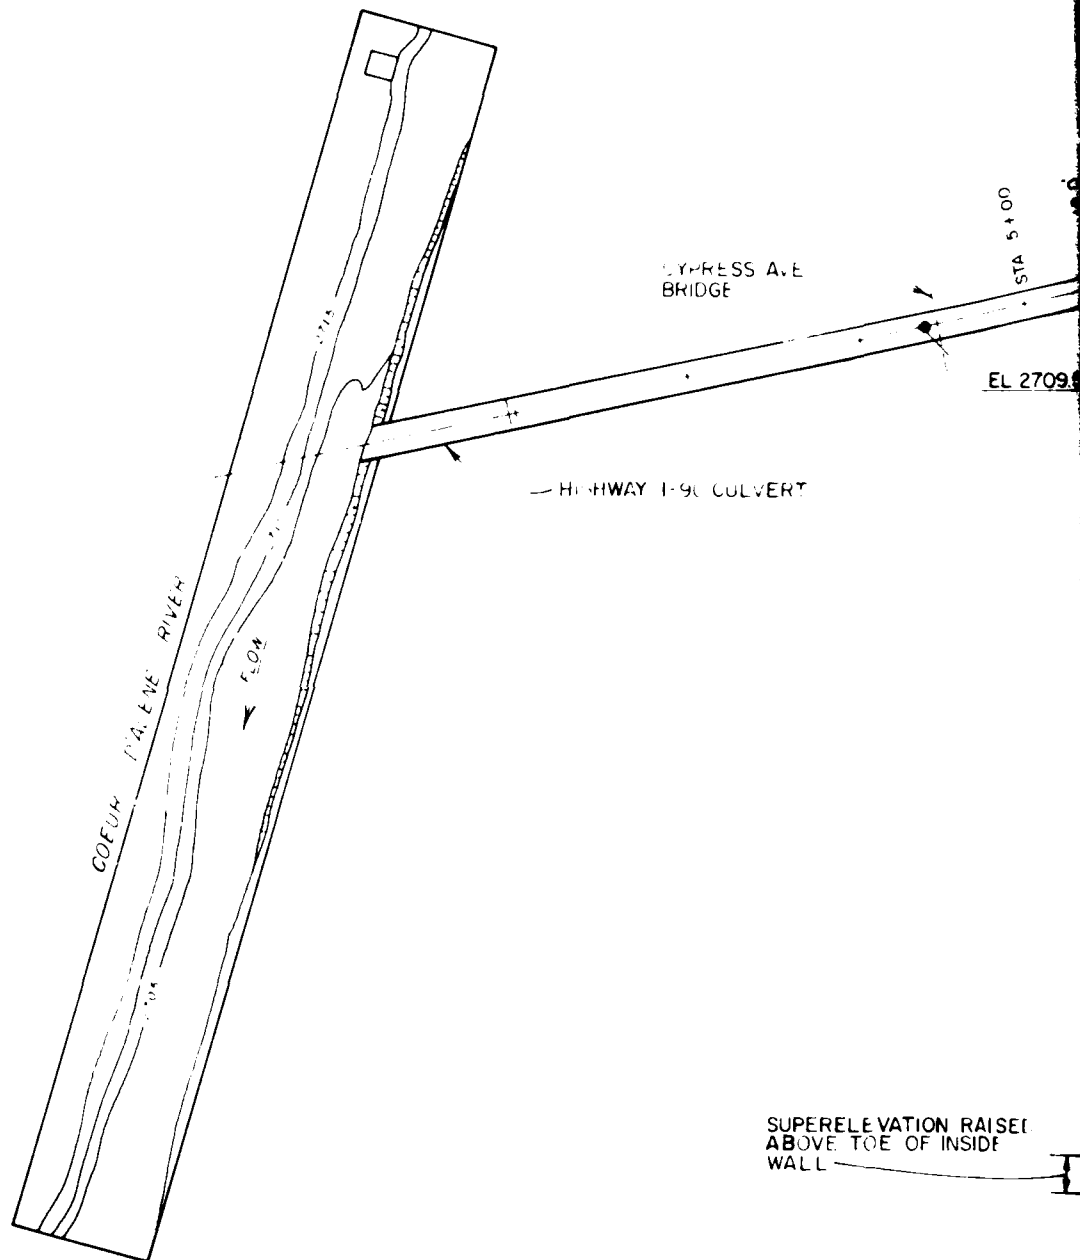
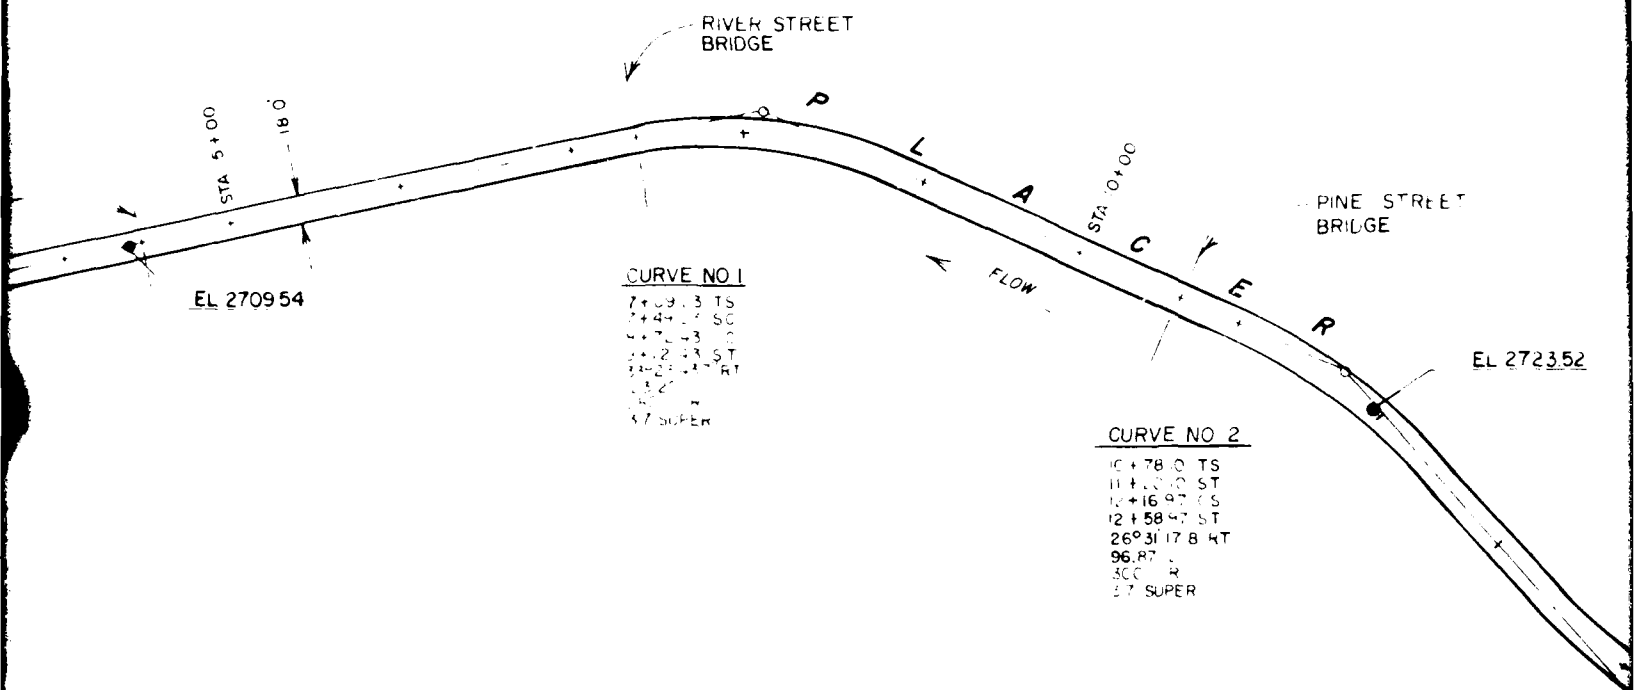
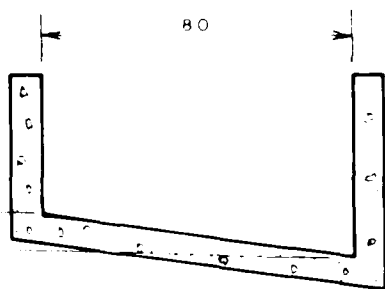
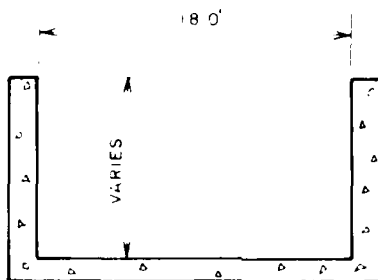
MODEL LAYOUT  
FINAL DESIGN

ERELEVATION RAISED  
VE TOE OF INSIDE

SECTION AT SUPERELEVATION

TYPICAL SECTION

41. With one minor modification, the original channel design proved to be hydraulically acceptable. The modification consisted of replacing two short reverse curves with a straight-line transition which corrected the condition. The water surface elevations as determined from the model were used to design the prototype wall heights.

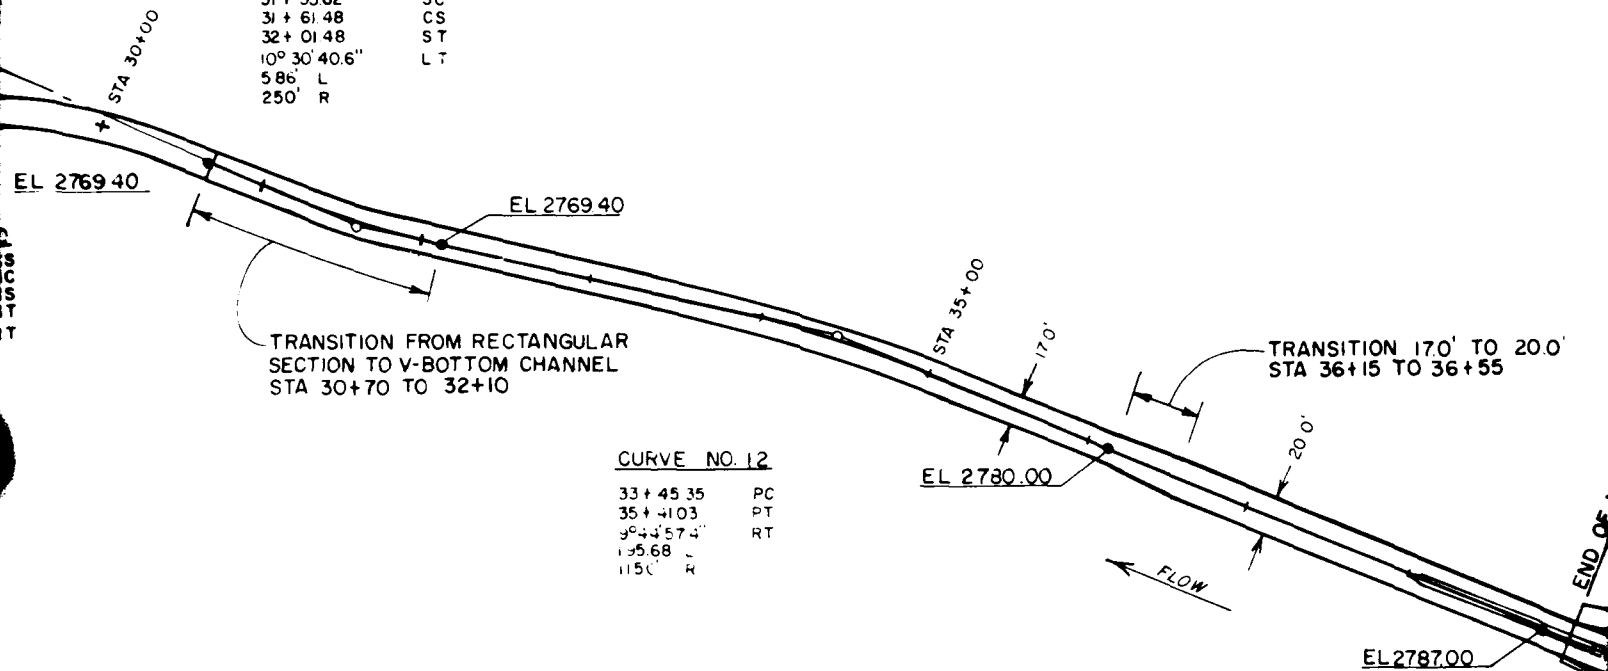
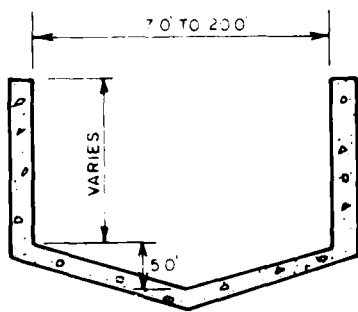
MODEL LAYOUT  
FINAL DESIGN

CURVE NO. 11

31 + 15.62 TS  
 31 + 55.62 SC  
 31 + 61.48 CS  
 32 + 01.48 ST  
 10° 30' 40.6" LT  
 586' L  
 250' R

CURVE NO. 12

33 + 45.35 PC  
 35 + 41.03 PT  
 9° 44' 57.4" RT  
 135.68 L  
 115' R

TYPICAL V-BOTTOM SECTION
